NBS BUILDING SCIENCE SERIES 143

Investigation of the Kansas City Hyatt Regency Walkways Collapse

DEPARTMENT OF COMMERCE • NATIONAL BUREAU OF STANDARDS

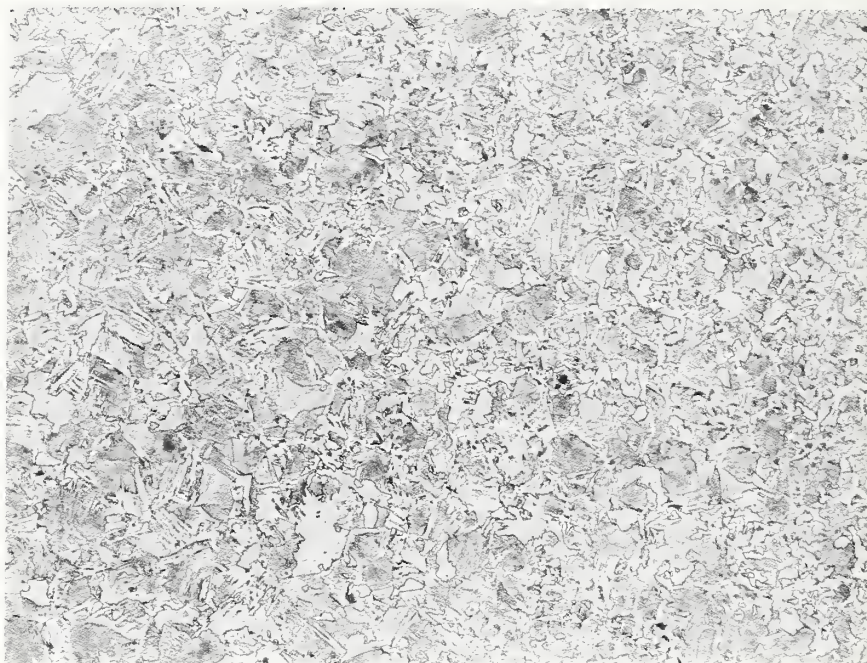
Figure A7.4.1-17 Region representative of the heat affected zone in section 1BM1. The microstructure appears to consist of ferrite, both as a network in prior austenite grains and as needles, bainite, partially spheroidized carbides, and tempered martensite. Etchant: two percent nital. X200

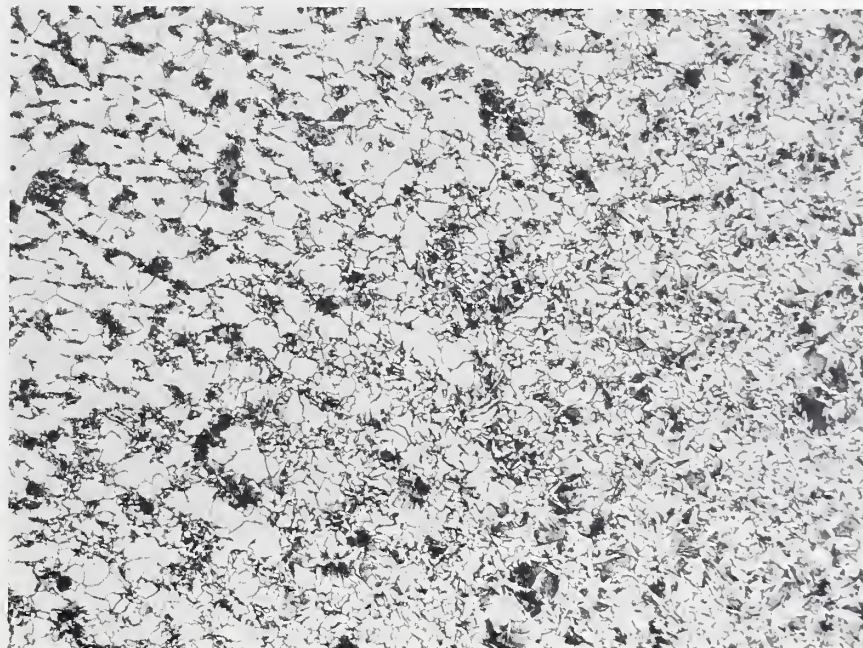
Figure A7.4.1-19 Transition from heat affected zone (right) to base channel material (left) in section 1BM2. Etchant: two percent nital. X200

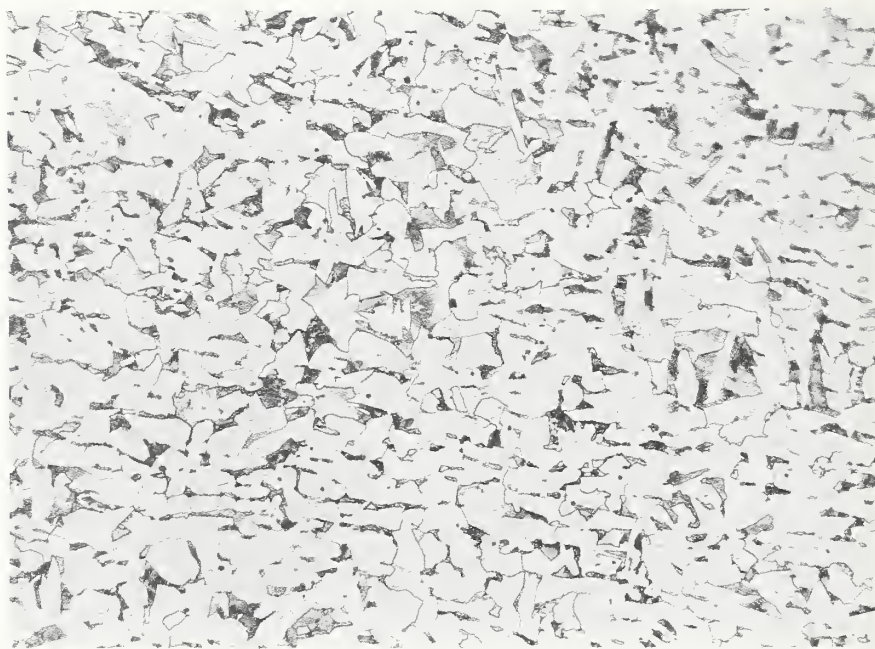
Figure A7.4.1-20 Region representative of base channel material in section 1BM1. The microstructure consists primarily of ferrite (light) and pearlite (dark) in the normalized condition. Etchant: two percent nital. X200

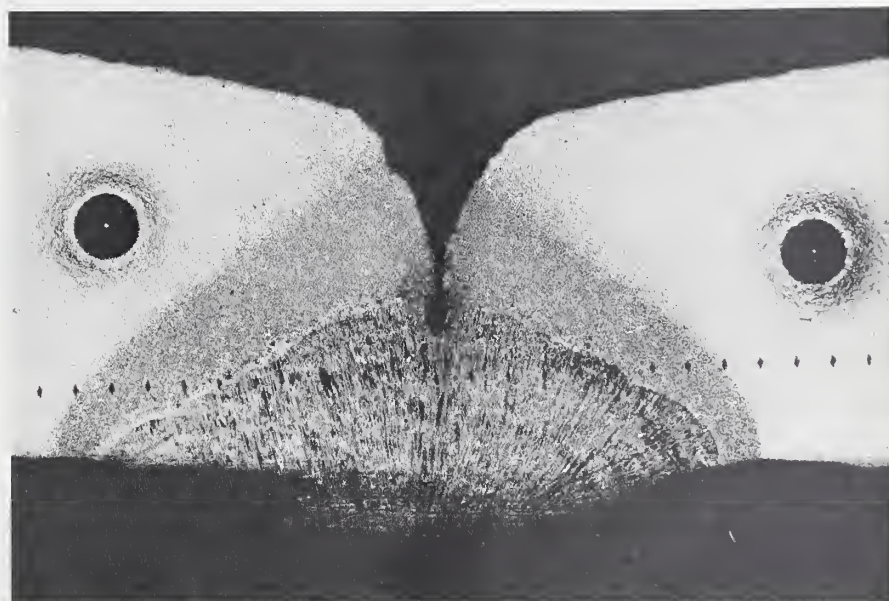
Figure A7.4.1-22 Part of the transverse section shown in figure A7.4.1-21, but at higher magnification. The region at the bottom center is weld metal. The dark gray regions on either side of the weld metal are the heat affected zones associated with the weld. The lighter regions on either side of the figure beyond the heat affected zones are base channel material.
Etchant: two percent nital. X8.5

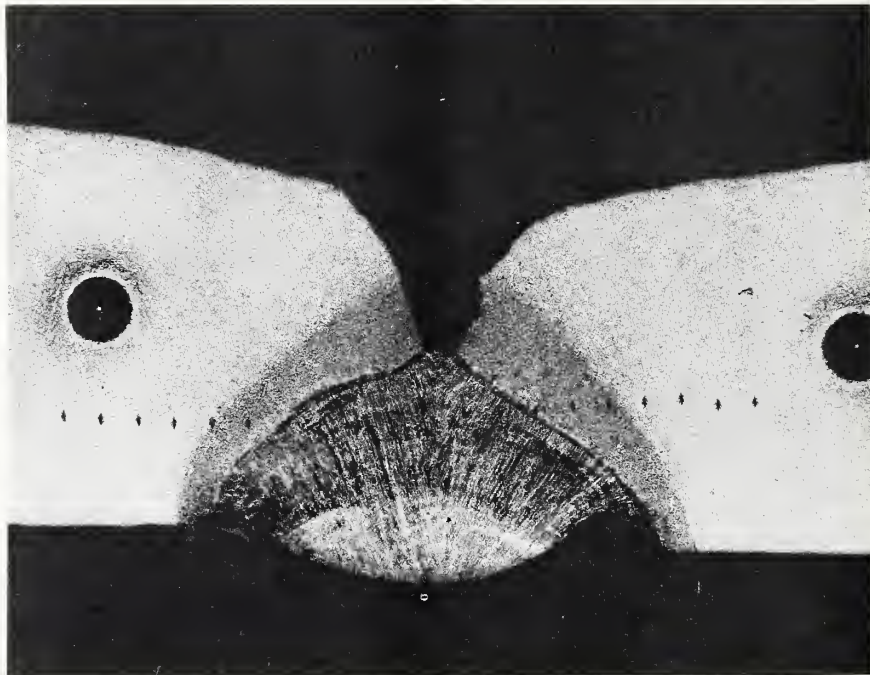
Figure A7.4.1-24 Part of the transverse section shown in figure A7.4.1-23, but at higher magnification. The region at the bottom center is weld metal. The gray regions on either side of the weld metal are the heat affected zones associated with the weld. The lighter regions on either side of the figure beyond the heat affected zones are base channel material. Etchant: two percent nital. X8.5

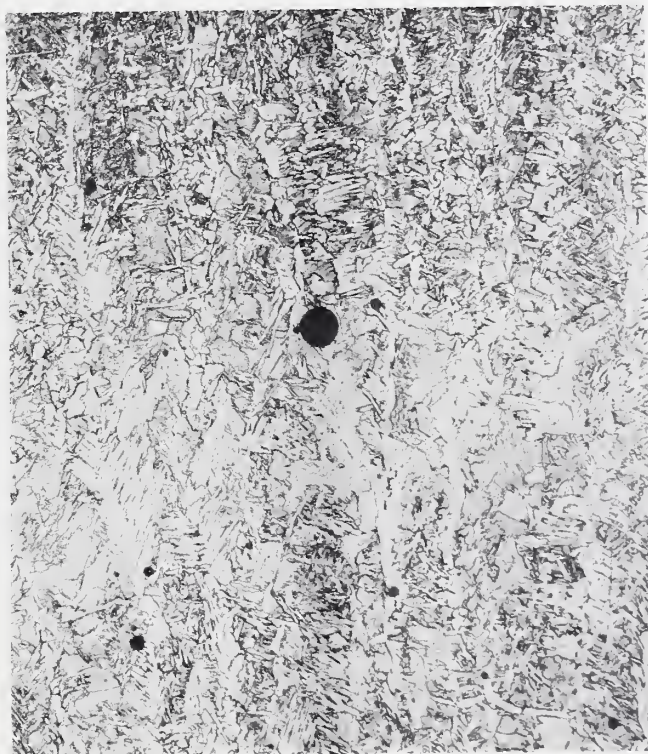
Figure A7.4.1-26 Representative microstructure of the weld metal in transverse section 2BM2 through box beam 8L (NBS 2). The microstructure appears to consist primarily of bainite. Some inclusions are evident. Etchant: two percent nital. X200

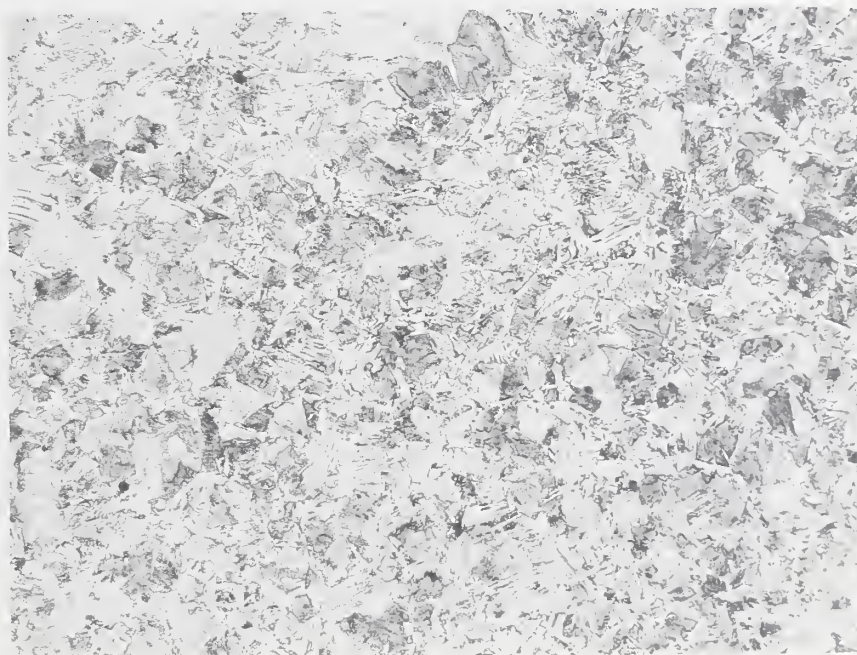
Figure A7.4.1-30 Representative microstructure of the heat affected zone in section 2BM1. The microstructure appears to consist of ferrite, both as a network in prior austenite grain boundaries and as needles, bainite, partially spheroidized carbides, and tempered martensite. Etchant: two percent nital. X200

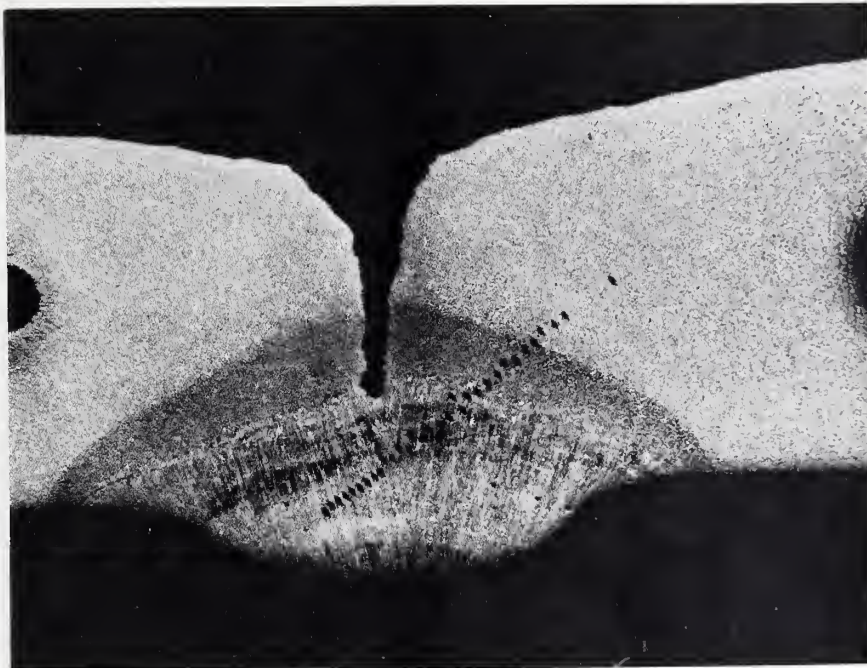
Figure A7.4.1-34 Part of the transverse section shown in figure A7.4.1-33, but at higher magnification. The region at the bottom center is weld metal. The gray regions on either side of the weld metal are the heat affected zones associated with the weld. The lighter regions at either side of the figure beyond the heat affected zone are base channel material. Etchant: two percent nital. X8.5

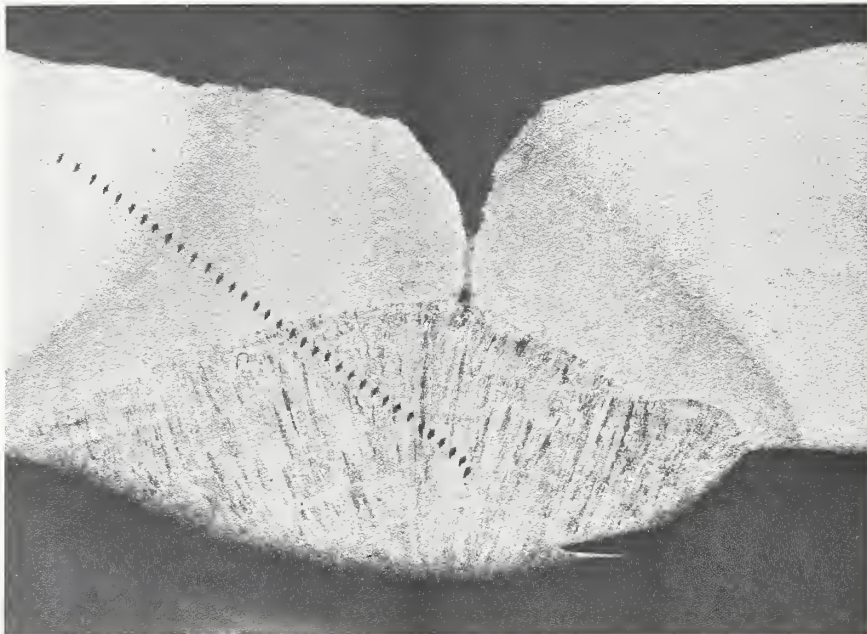
Figure A7.4.1-36 Part of the transverse section shown in figure A7.4.1-35, but at higher magnification. The region at the bottom center is weld metal. The gray regions on either side of the weld metal are the heat affected zones associated with the weld. The lighter regions at either side of the figure beyond the heat affected zones are base channel material. Etchant: two percent nital. X8.5

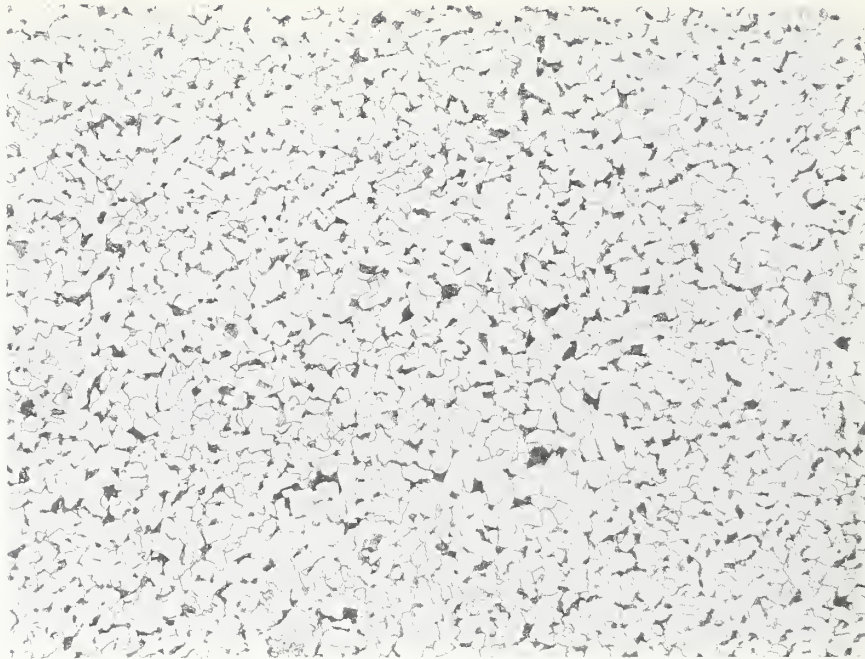
Transverse and longitudinal sections from each of the walkway hanger rod segments obtained from the debris (NBS 5A and 5B) were examined metallographically. The locations of these sections in the hanger rods are shown in figure A7.3.3-1. A representative region showing the etched microstructure of the transverse section from hanger rod NBS 5A is shown in figure A7.4.2-1. The

microstructure consists of ferrite (light) and pearlite (dark) in a reasonably fine grained (ASTM grain size 9) normalized structure.

Figure A7.4.2-1 Transverse section through hanger rod NBS 5A showing the representative microstructure. The microstructure consists of relatively fine grained ferrite (light) and pearlite (dark) in a normalized condition. Etchant: two percent nital. X100

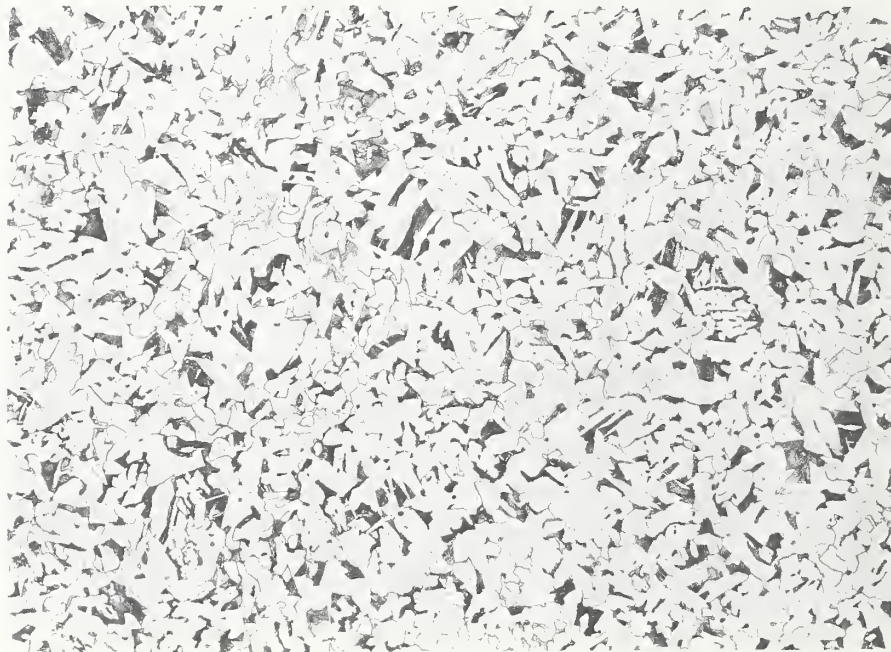
The representative microstructure of the transverse section from hanger rod NBS 5B is shown in figure A7.4.2-2. The microstructure again consists of ferrite (light) and pearlite (dark) in the normalized condition. This microstructure is coarser (ASTM grain size 7-1/2 to 8) than that of hanger rod NBS 5A, and there appears to be more pearlite present than in hanger rod NBS 5A.

Figure A7.4.2-2 Transverse section through hanger rod NBS 5B showing the representative microstructure. The microstructure consists of ferrite (light) and pearlite (dark) in a normalized condition. Etchant: two percent nital. X100
